# CERTIFIED BUILDING INSPECTORS

## HOME INSPECTION REPORT

**123 Sample St.  
Orlando, FL 32888**

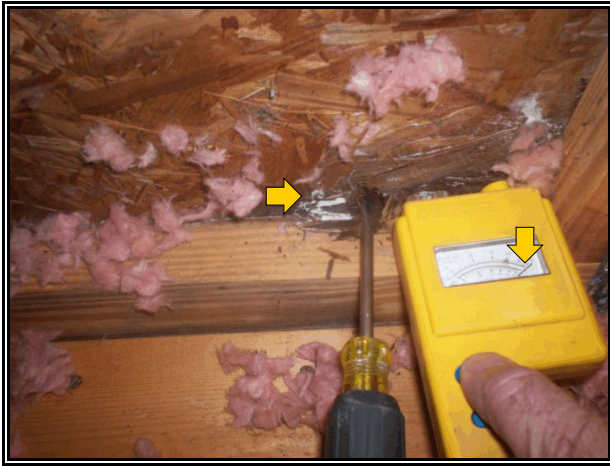
1. The damage by wood decay fungi as follows;
  - \* sections at the base of the siding of the right gable end as seen in the attic, (See photos 1 and 2.)

- \* the right side wall toward the rear of the front bedroom and behind the right wall of the hall bath shower where water is entering at the seam at the base of the right side gable end wall, (Again, see photos 1, 2 and 4.)

(NOTE - The surface conditions observed in these area are likely accompanied by hidden damage. There is weakness in the exterior wall around the window and at the right interior right tiled wall of the shower in the bath; however, we are unable to verify the extent of associated damage without accessing the areas behind the surfaces. Such invasive or destructive evaluation techniques are not conducted as part of our service to you. This situation should be remedied as needed including correction of any hidden damage uncovered while addressing the surface conditions. Often, wall areas need to be opened to assess the conditions therein. This condition should be referred to a residential contractor at this time for further evaluation.)

Photo 1- Wood decay and increased moisture at the base of the right gable end siding in the attic.

At this time these conditions should be referred to a residential contractor for further evaluation and correction as needed.

Wood decay fungi or rot damage to wood members was observed as identified in the Synopsis also. These conditions should be corrected as needed before closing on the home.

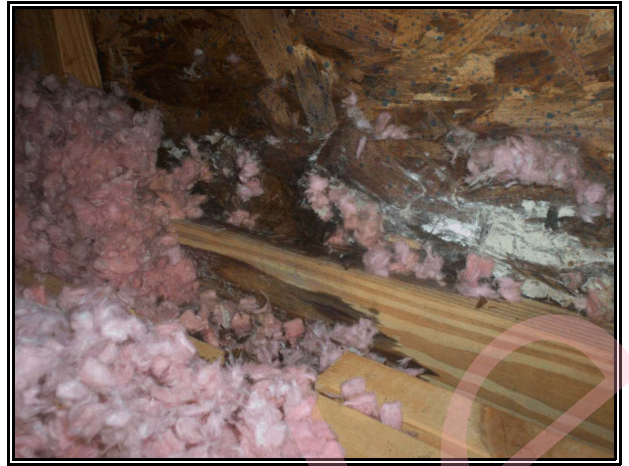
Photo 2- Another decayed section of the right gable end siding above the hall bath wall below.

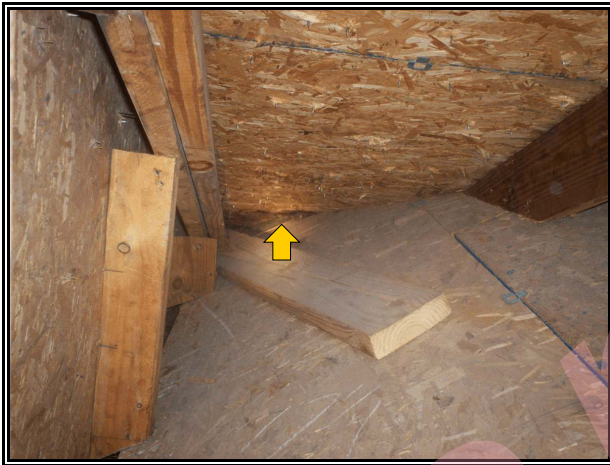
- \* a section of the roof sheathing at the base of the valley to the right rear of the garage, (See photo 3.)
  - \* the base of the jambs of the front entry door,

Photo 3- Wood decay at a section of roof sheathing below the base of the valley right of the garage.

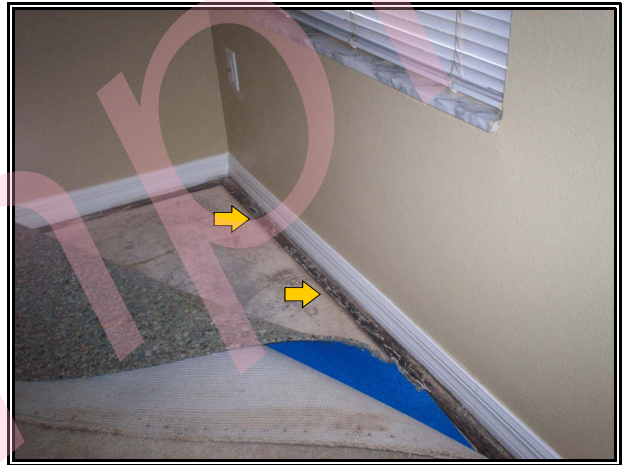
- \* sections of the carpet tack strip at;
    - the base of the right wall of the right front bedroom below and to the rear of the window, (See photo 4.)

Photo 4- Decay damaged section of the moist tack strip in the right front bedroom.

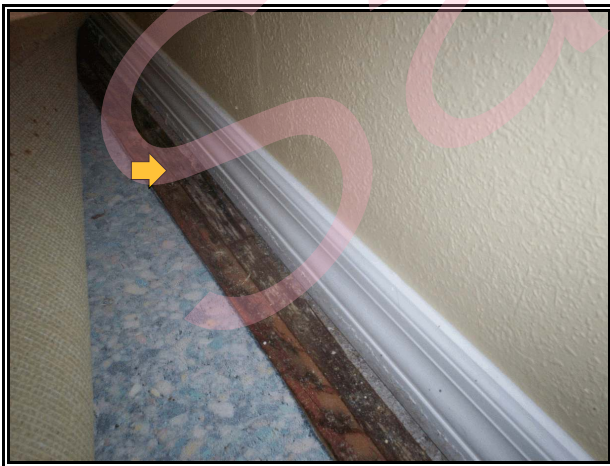
- the base of the wall below the right jamb of the window assembly to the front of the living room. (See photo 5.)
2. Moisture intrusion into the home as evidenced by the moisture staining and increased moisture levels detected with a moisture meter at;

- \* below the window at the front of the dining room, (See photo 6.)
  - \* below the window at the front of the living room, (Again, see photo 5.)
  - \* at the base of the right jamb of the rear sliding glass door assembly.
3. Pests entering the attic space at the displaced soffit segment at the right end of the eave to the right of the front door. (See photo 7.)
4. With the rain gutters;
  - \* loose down spout segments at the left front corner of the house (see photo 8) and at the right side of the house,
  - \* the right end of the run above the living room windows is disconnected and hanging down, (See photo 9.)

Photo 5- Decay damaged and slightly damp carpet tack strip at the front of the living room.

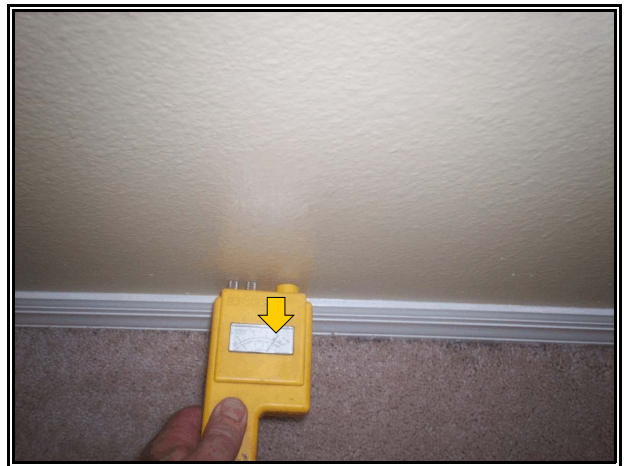
Photo 6- Increased moisture at the wall below the dining room window. The tack strip below is stained as well.

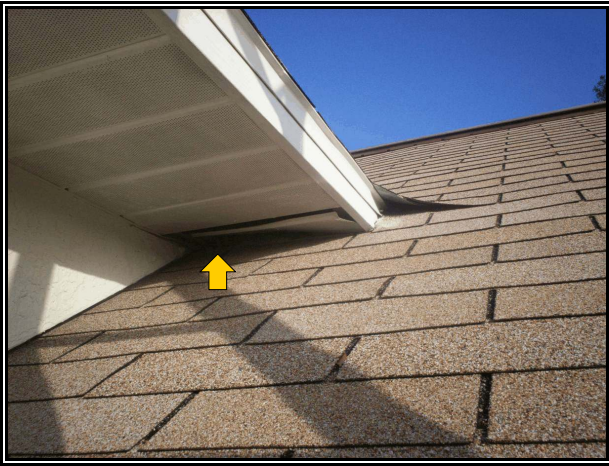
In the attic we did see indication of rodent activity as evidenced by the presence of "trails" in the insulation and "droppings". The pests appear to be entering at the displaced soffit segment identified in the Synopsis. There may be other entry points as well. We recommend that you refer this matter to a pest control company for evaluation and treatment as needed. Also, live ants were seen below the carpet at the base of the right jamb of the rear sliding glass door and below the carpet at the left rear corner of the master bedroom. You may want to have the pest control company assess this issue also.

Photo 7- The displaced soffit cladding allow pest entry to the attic.

We did detect pest entry at the front of the attic at the displaced soffit segment identified in the Synopsis. This opening should be sealed to eliminate this access.

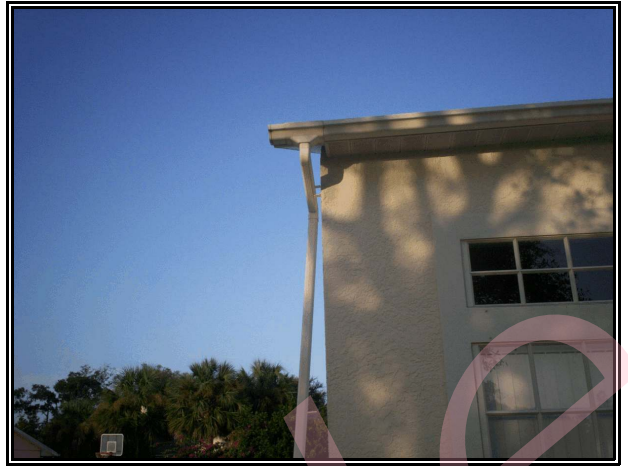
Photo 8- The loose rain gutter down spout at the left front corner of the house.

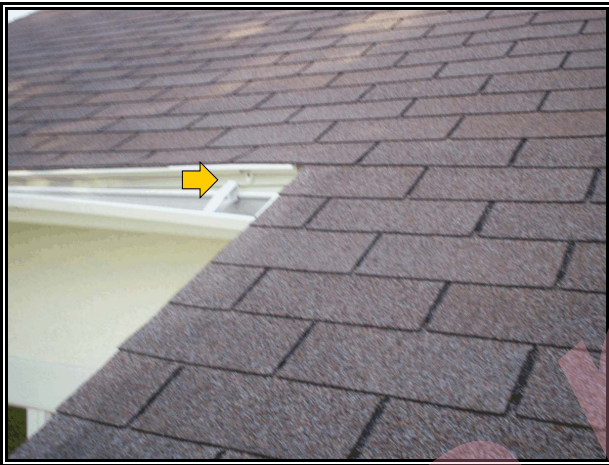
Photo 9- The disconnected run to the front of the living room.

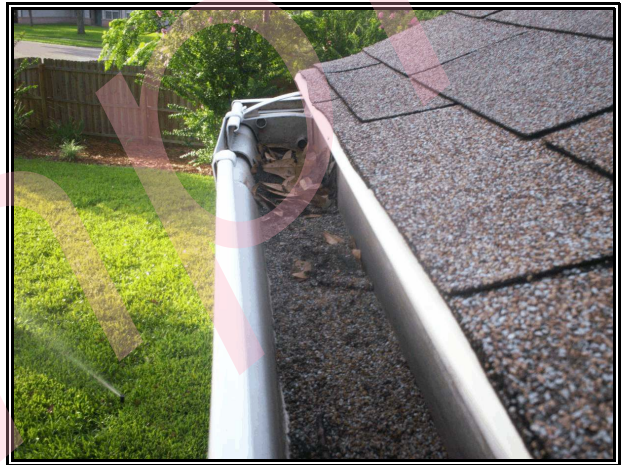
- \* the runs are somewhat clogged with plant debris and granules off the shingles preventing them from draining properly. (See photo 10.)
- 5. With the plumbing components;

Photo 10- One of the partially clogged rain gutter runs.

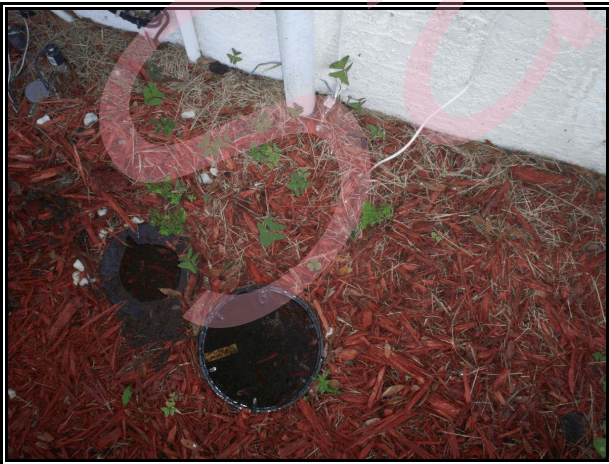
- \* the missing drain stopper at the hall bath tub,
  - \* the missing caps at the right side in ground wells for the domestic water and lawn sprinkler shut off valves. (See photo 11.)

Most of the fixtures have shut off valves below. The main shut off for the water supply is located at the right exterior of the home. The cover to the well housing it is missing as noted previously however. (Again, see photo 11.) This should be replaced.

Photo 11- The missing caps at the domestic and lawn sprinkler shut off valves right of the home.

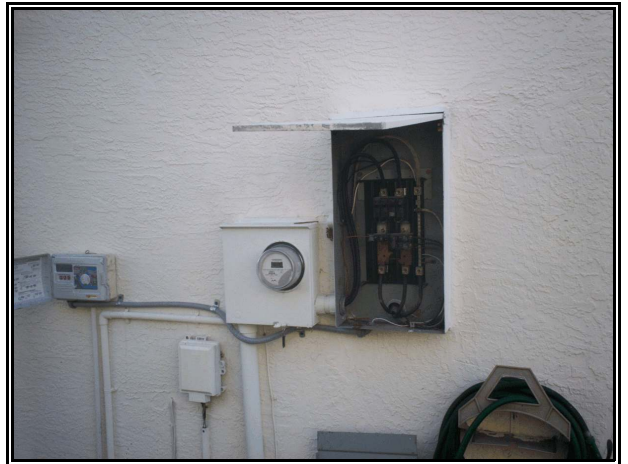
The main service into the home consisted of an underground, 120/240 volt feed, aluminum service entrance cables and a main disconnect rated at 150 amps. The disconnect was located adjacent to the meter on the right exterior wall of the house. (See photo 12.) The service was grounded on the exterior.

Photo 12- The main 150 amp disconnect panel and active lawn sprinkler panel right of the home.

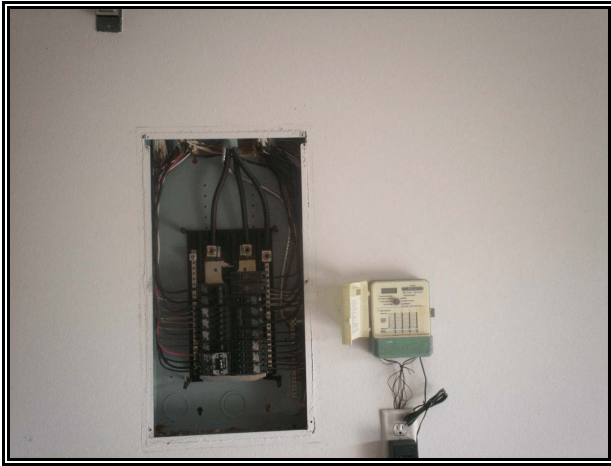
The sub panel breaker box was located in the garage. (See photo 13.) In this panel the breakers and corresponding lines were all properly sized and connected. There was room in the box for additional lines or breakers that may be required in the future.

The system has two automatic timers. The unit at the right interior wall of the garage appears to have been abandoned. The control panel at the right exterior wall of the garage is functional. This device was not checked through its full cycle. We merely turned the unit to the manual setting and checked the cyclematic rotation and flow of the sprinkler valves.

Photo 13- The electrical sub panel in the garage and inactive lawn sprinkler panel adjacent.

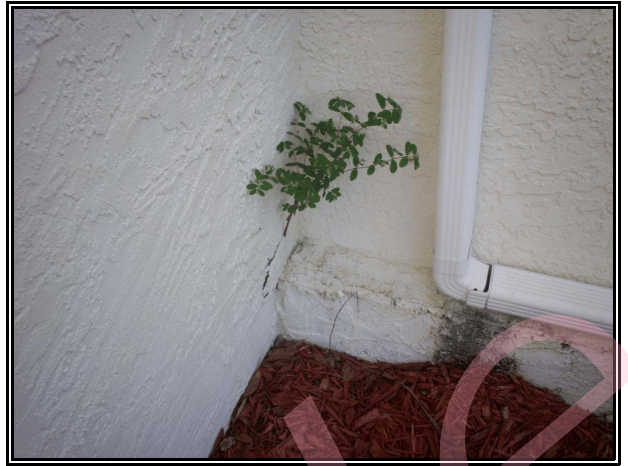
There is a crack at the base of the left wall near the front corner behind the decorative wing wall. The crack is not unusual, but there is a small shrub growing in it. This plant should be removed. There were also plants seen growing from the threshold area of the front door also. These too should be removed.

Miscellaneous photo of the plant growing in the crack at the left side of the home.

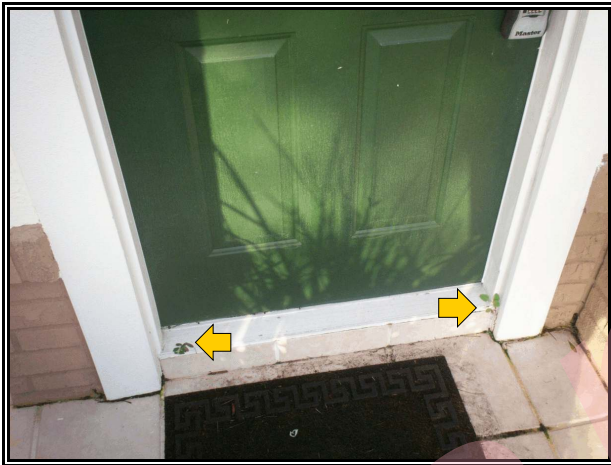
Miscellaneous photo of the live plants at the front entry near the decay damaged wood.

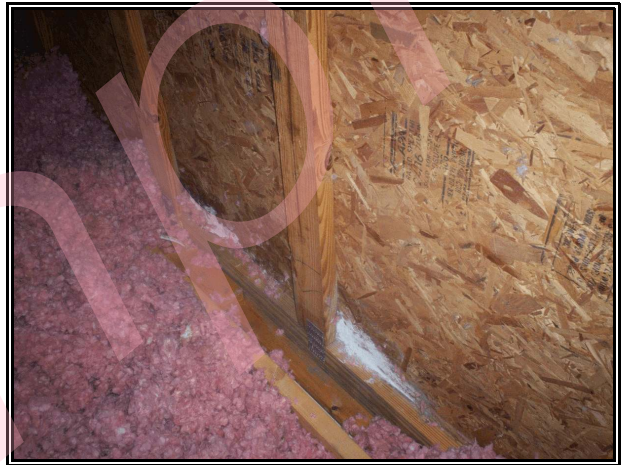
Miscellaneous photo of mold growing at other areas at the base of the right gable end siding.

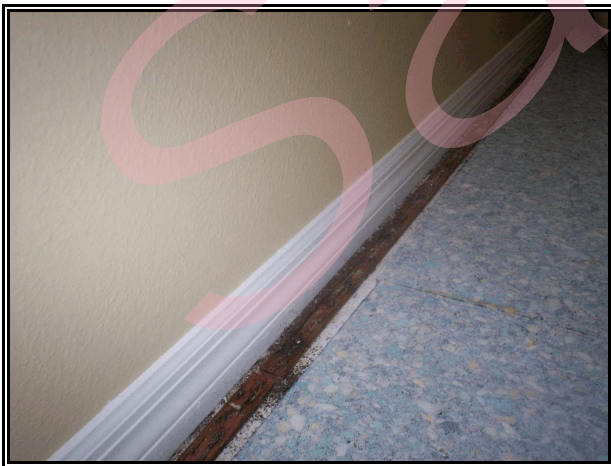
Miscellaneous photo of the water stained carpet tack strip at the front of the dining room.
